# Manhole Inspection Summary

Manhole # S07KK1002MH

Insp Date: **5/18/07 10:46 AM**

**Location** Address: **4914 REISTERSTOWN RD**

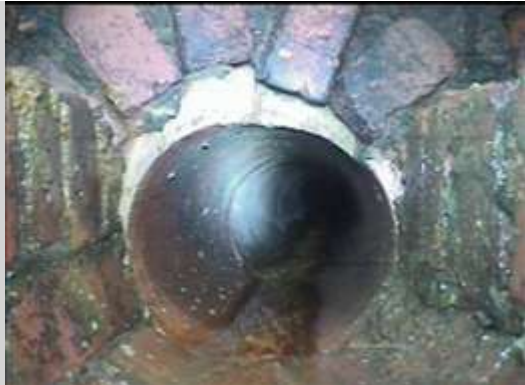
12 O'Clock Outflow

8 in. Circular Gravity Sewer  
Pipe Out @ 12 O'Clock

Pipe Material: **Clay** ☐ Pipe Lined

Invert Depth: **6.93** (ft.) Flow Characteristics: **Slow**

Infiltration: **None** Pipe Seal Cond: **Sound**

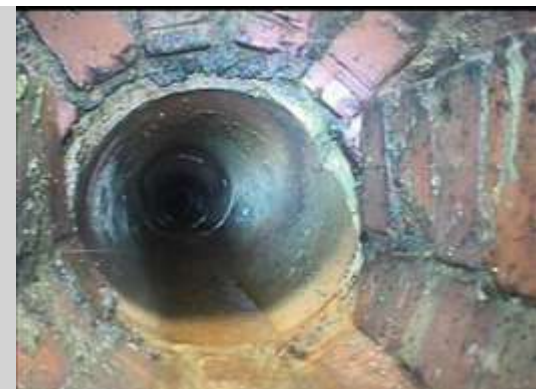
6 O'Clock Inflow

8 in. Circular Gravity Sewer  
Pipe In @ 6 O'Clock

Pipe Material: **Clay** ☐ Pipe Lined

Infiltration: **None**
